# Home Inspection Report

**123 Main Blvd, Greenville, NC 27858**

Tuesday, September 14, 2021

832-091-021

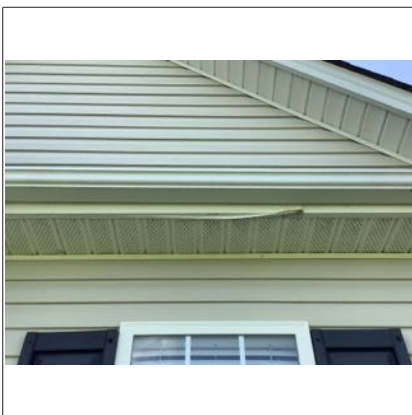
**Comments:** 1. There is an area of detaching metal trim on the right front of home. This can allow water entry and damage to wooden components behind the metal wrap can occur. Recommend a skilled professional make repair.

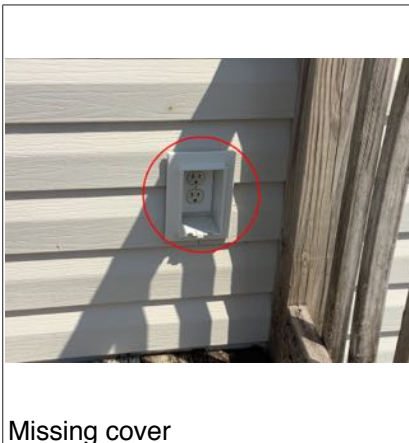
Missing cover

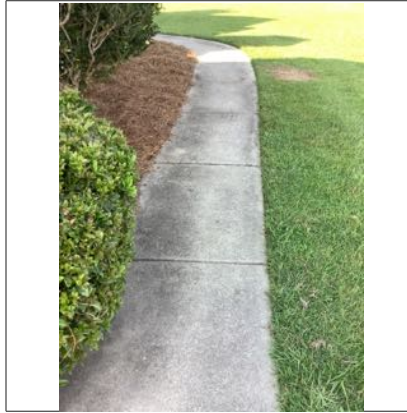
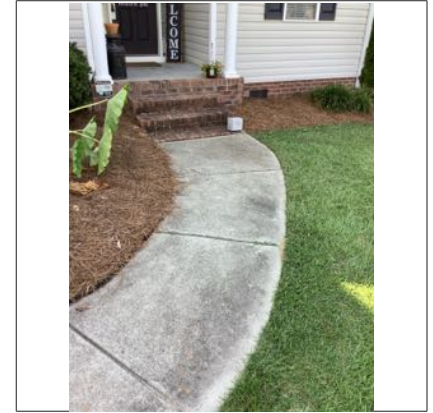
1. Some of the bricks in the service walks around the home are uneven. Some are close to being considered a trip hazard. Recommend a skilled professional make adjustments/repairs.

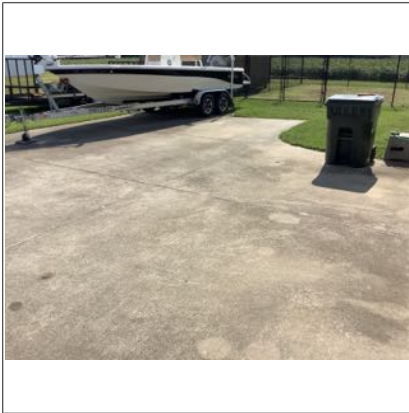
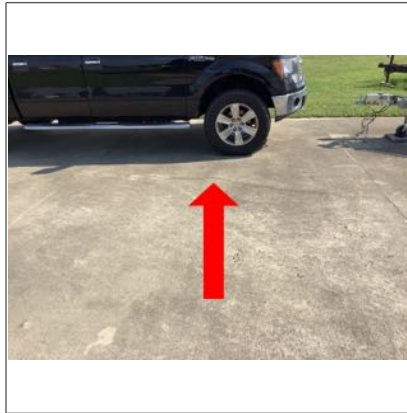
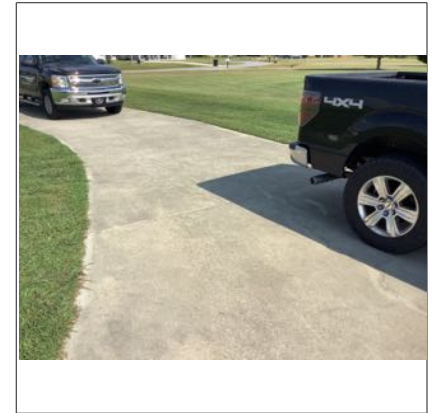
**Comments:** 1. The driveway of the home is useable, but there is typical cracking that has occurred over time. Water can enter these cracks and cause further damage in colder months. Recommend the cracks be cleaned of debris and sealed by a skilled professional.

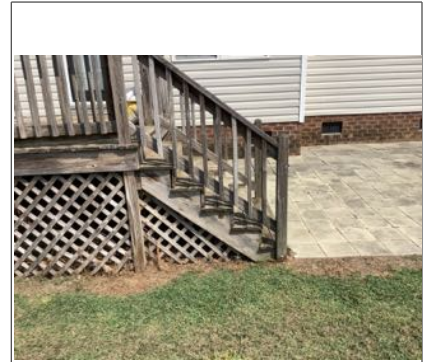
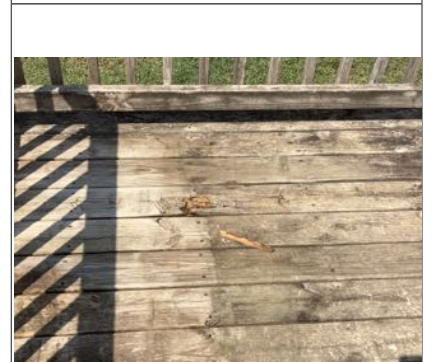
**Comments:** 1. There is a broken baluster on the porch. Further damage may occur if left in this condition and the balusters will not be properly spaced. Recommend a skilled professional make repair.  
 1. There was non-removable lattice work below the porch. This area could not be entered by the inspector. There may be defects present that were not visible.  
 1. There are areas of deteriorated wood on the railings/balusters on the porch. Further deterioration will occur if left in this condition. Recommend a skilled professional make repairs.

**Safety Concern: 1. The railings on the porch are loose.** The railings do not appear to be properly supported and may continue to loosen and detach. This is a safety concern. Recommend a skilled professional/qualified contractor make repairs.

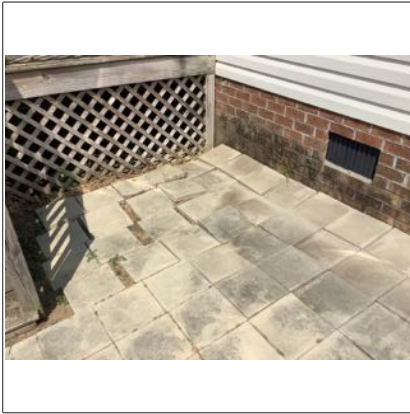
Condition  Safety Hazard  Upheaval

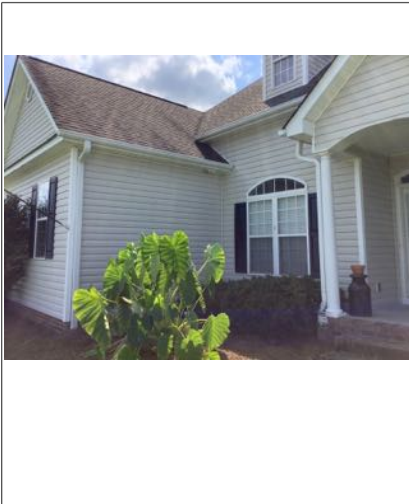
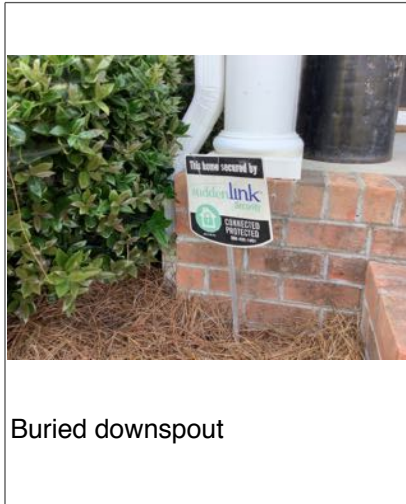
**Comments:** 1. There are buried downspout elbows on the gutters. The gutters will not drain properly. Recommend the gutters be cleaned and all necessary repairs be made by a skilled professional. Gutters appear to empty into front flower beds and may pool causing foundation issues in future. Owner may wish to have these evaluated and necessary repairs made.

Buried downspout

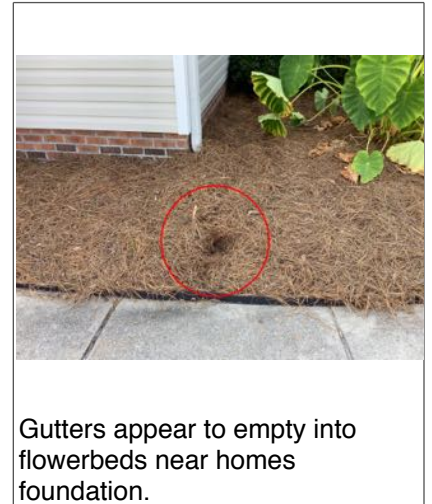
Gutters appear to empty into flowerbeds near homes foundation.

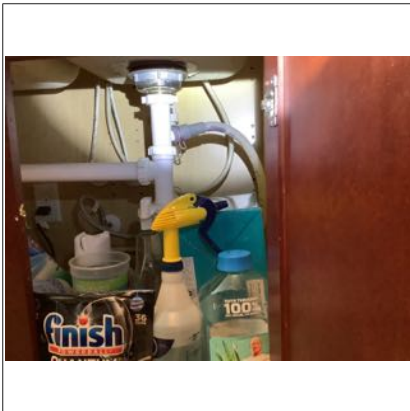
1. The dishwasher drain line is not attached high on the cabinet wall under the sink to prevent back flow. This is a sanitation concern because if the sink backs up, water from the sink could drain into the dishwasher. Recommend a skilled professional/qualified plumber refer to the manufacturers instructions and properly install the drain line.
2. Microwave exhaust is blocked by cabinetry. Not properly routed. Owner may wish to have qualified professional make necessary repairs.

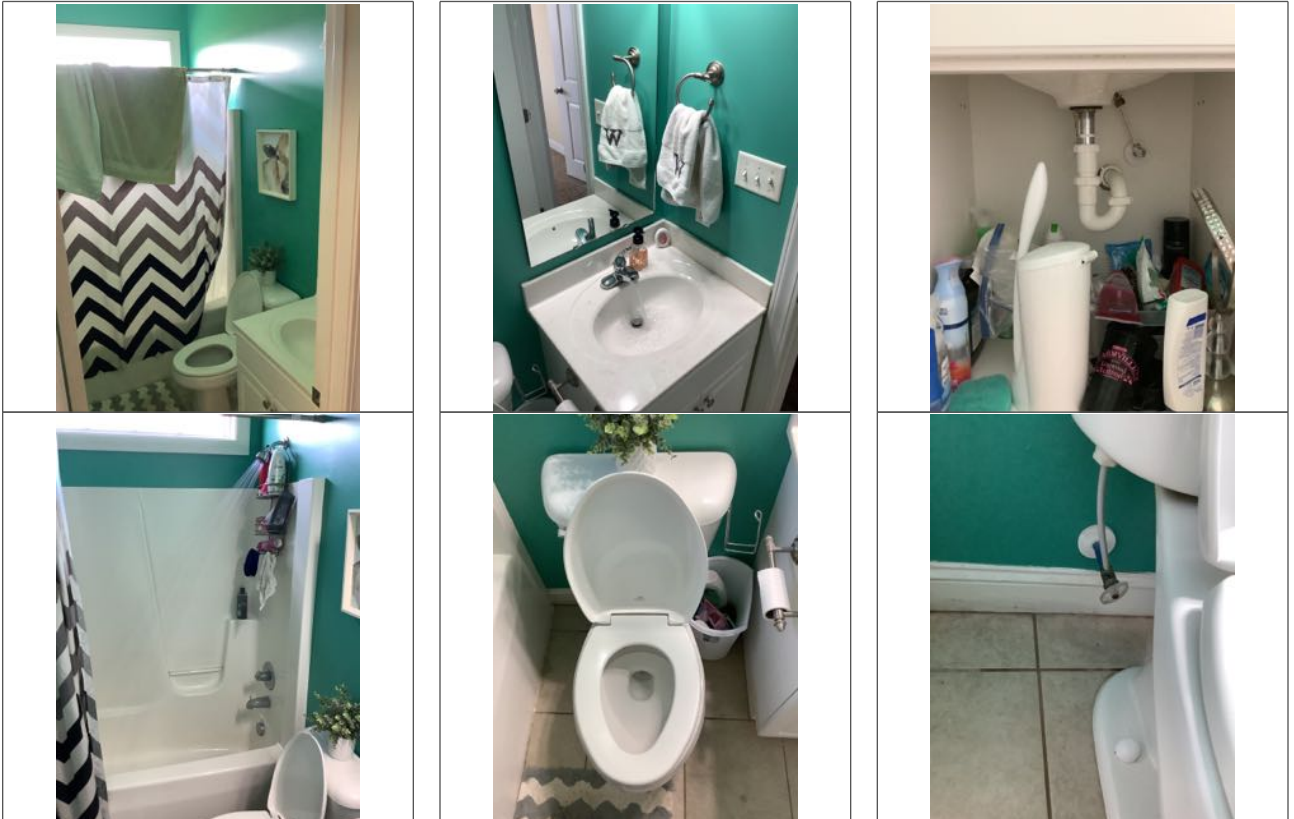
**Comments:** Further Evaluation Item: 1. The drainage in the sink is slow/marginal in the bathroom. The sink is not draining properly. If a clog cannot be removed from the drain, recommend a qualified plumber evaluate and make repair.

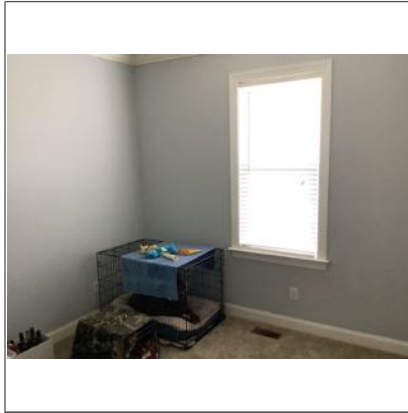
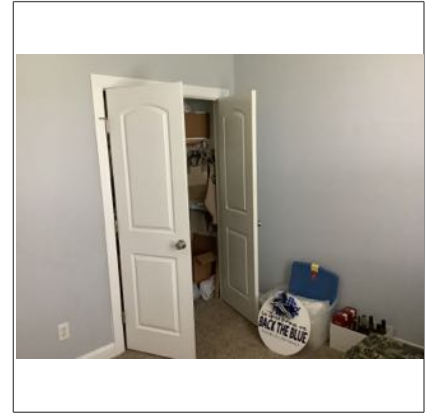
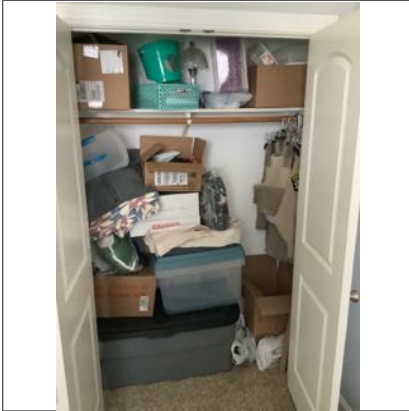
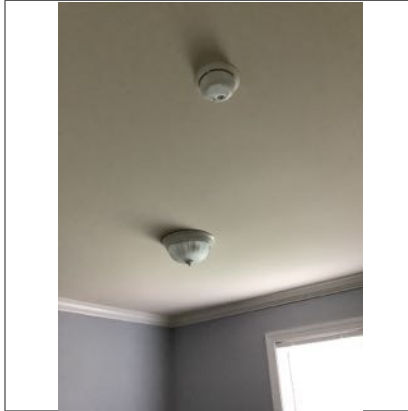
**Comments:** Smoke detector within this room is not operational. Did not test property. recommended replacement immediately.

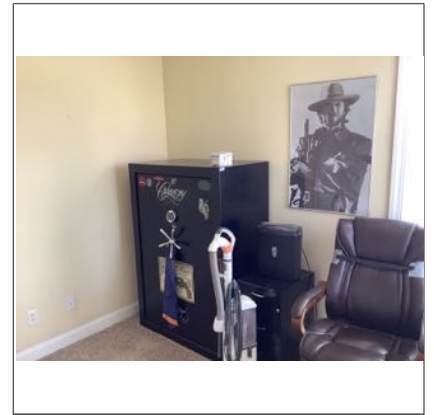
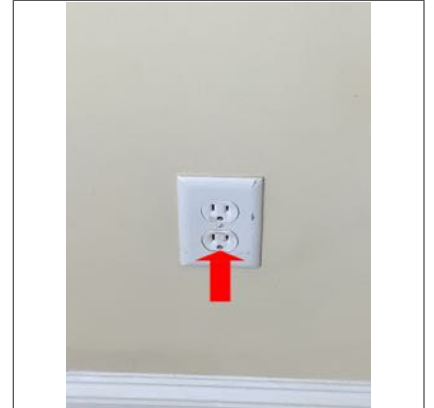
**Comments:** 1. There is an object stuck in the slot of an outlet in the room. The outlet cannot be used and this could become a shock hazard. Recommend a skilled professional/qualified electrician remove the object.

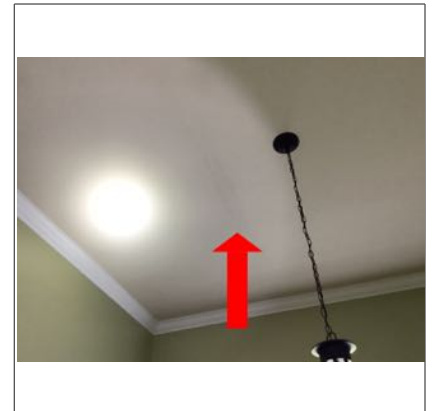
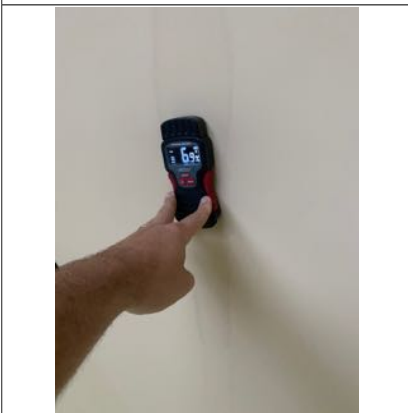
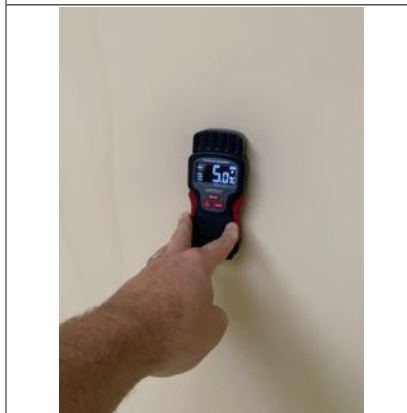
**Comments:** 1. There is an area of what appears to have been staining that was painted over on the ceiling in the room. This area was tested with a surface moisture meter and the meter indicated low levels of moisture in some spots at the time of inspection. In some cases moisture meters can give false readings when they come in contact; or within close proximity to metal. It is difficult to determine if this is an active leak. The client may wish to have a more invasive inspection in this area by a skilled professional. At a minimum recommend monitoring and if further deterioration, staining or cracking occur recommend a skilled professional/qualified contractor evaluate the condition.

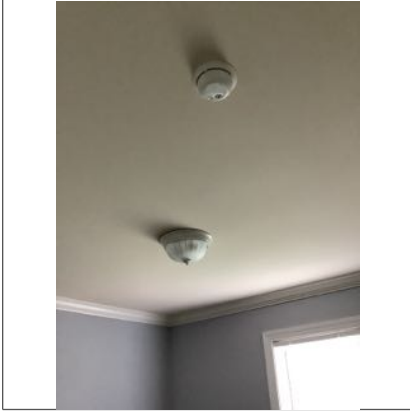
Smoke Detector(s)  Detector(s) appears to be over 10 years old recommend replacement

Comments: Some detectors where not operational and need to be replaced.

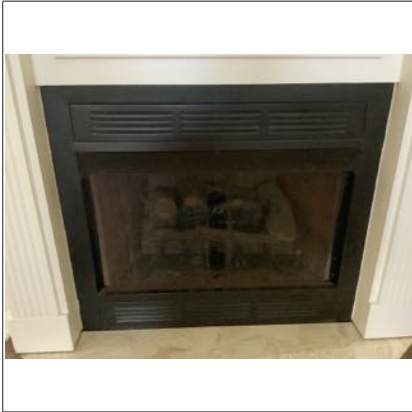
- Type**  Gas Fireplace(s)  
**Material**  Metal (pre-fabricated)  
**Blower**  Blower not operational  
**Damper**  None  
**Flue**  Not fully evaluated  
**Hearth Ext.**  Satisfactory  
**Mantle**  Satisfactory  
**Firebox**  Satisfactory  Only partially visible  
**Condition**  No gas source not evaluated  Pilot light not lit not evaluated  Not fully evaluated  
 Type of gas logs, propane vs natural gas was not determined

1. The gas fireplace in the living room was not tested due to the fact there was no gas supply for the unit.
1. The gas fireplace was not fully evaluated. The gas supply was turned off to the unit. Recommend a qualified chimney sweep evaluate the unit.

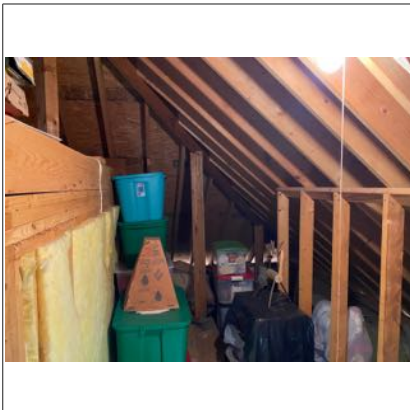
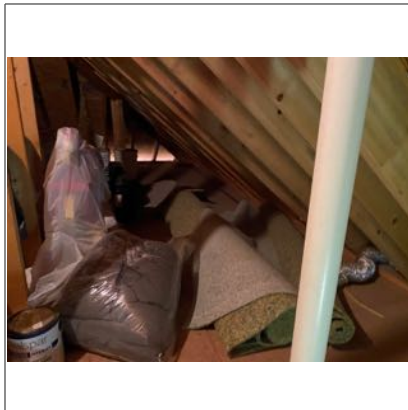
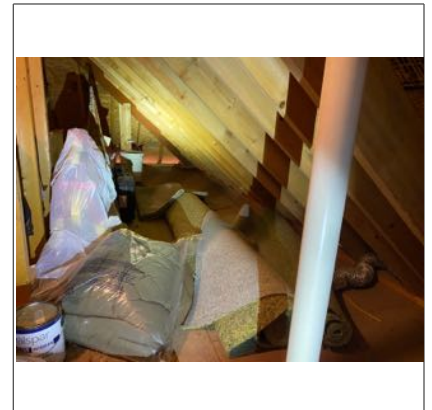
**Comments:** 1. There is limited access in the attic. The attic was inspected from the floored in area(s) only. Some areas are too small to safely move, and the attic is not floored in. There may be defects present that were not visible. The client may wish to consult with a qualified contractor, to determine the feasibility of installing additional entry points, or flooring.

Dormer window located within attic. There is evidence of past water intrusion around this windows and staining on the attic floor. Further evidence of water intrusion is located in the dining room ceiling. These spots were tested using a moisture meter and showed no moisture differential between stain and surrounding areas.
