# Home Inspection Report

**123 Main Blvd, Greenville, NC 27858**

Tuesday, September 14, 2021

832-091-021

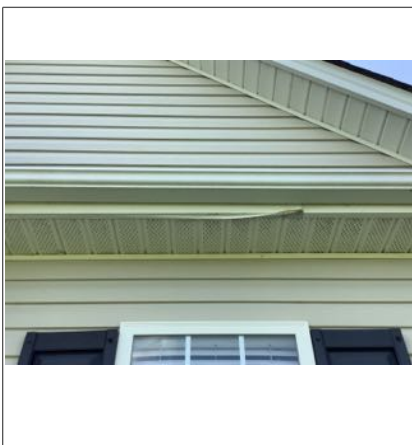
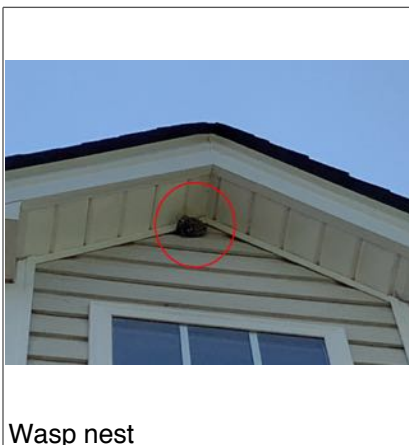
**Comments:** 1. There are flying insect nests on the soffit on the exterior of the home. These may be stinging insects and caution should be taken when removing them. The client may wish to consult with a qualified pest control specialist.

Wasp nest

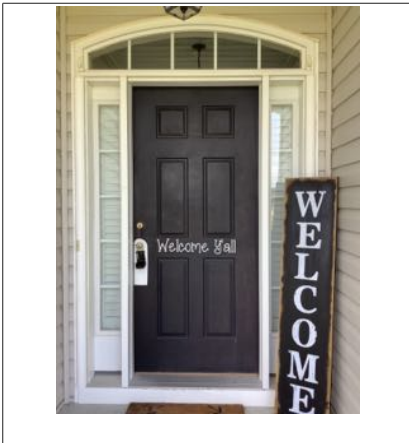
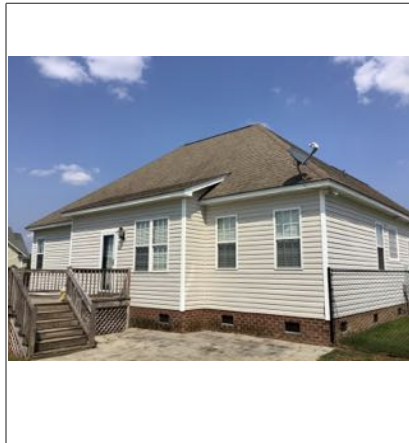
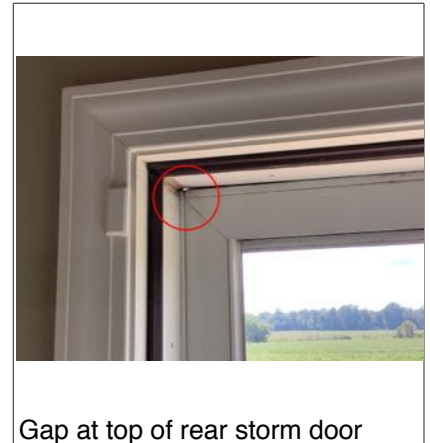
**Comments:** The rear door and rear storm door appear to be sagging causing gaps at the top of both. Recommend have professional make necessary repairs to avoid insect and water intrusion into home.

Gap at top of rear storm door

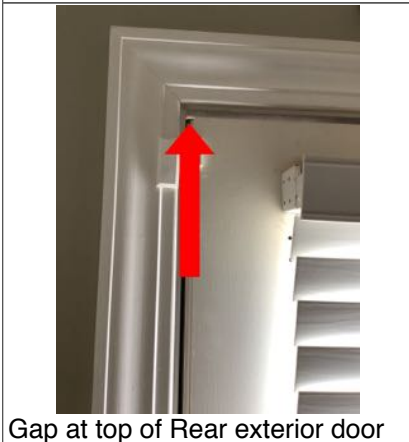
Gap at top of Rear exterior door

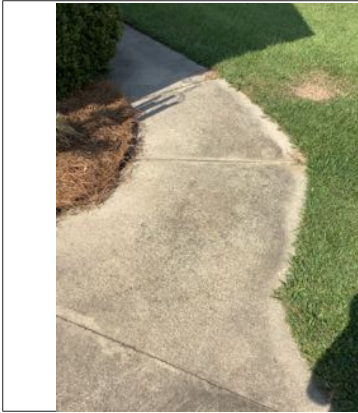
1. Some of the bricks in the service walks around the home are uneven. Some are close to being considered a trip hazard. Recommend a skilled professional make adjustments/repairs.

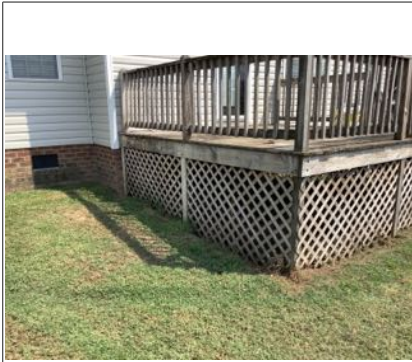
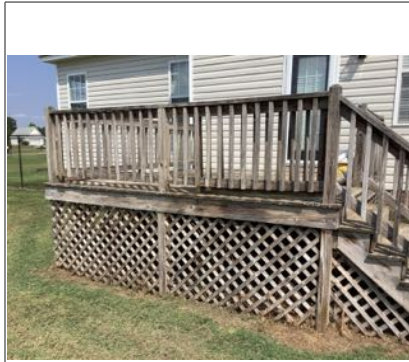
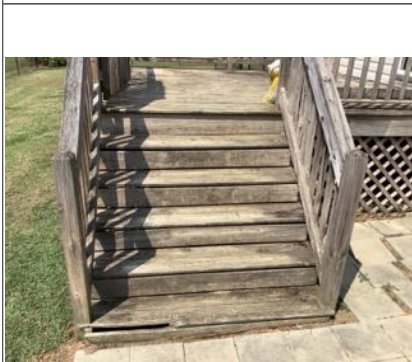
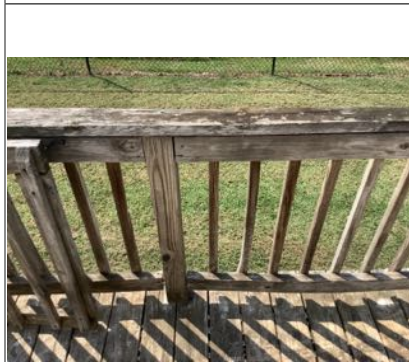
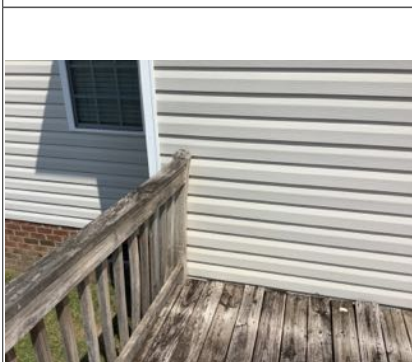
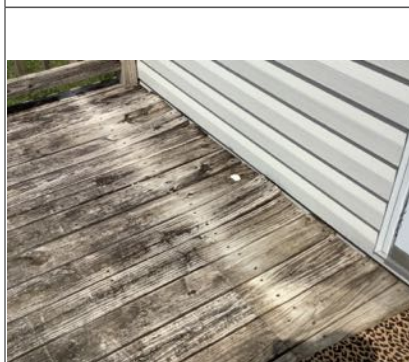
**Safety Concern: 1. The railings on the porch are loose.** The railings do not appear to be properly supported and may continue to loosen and detach. This is a safety concern. Recommend a skilled professional/qualified contractor make repairs.

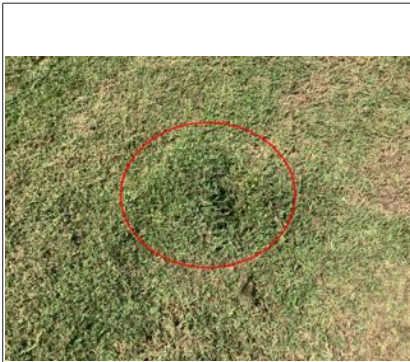
Hole located in rear yard

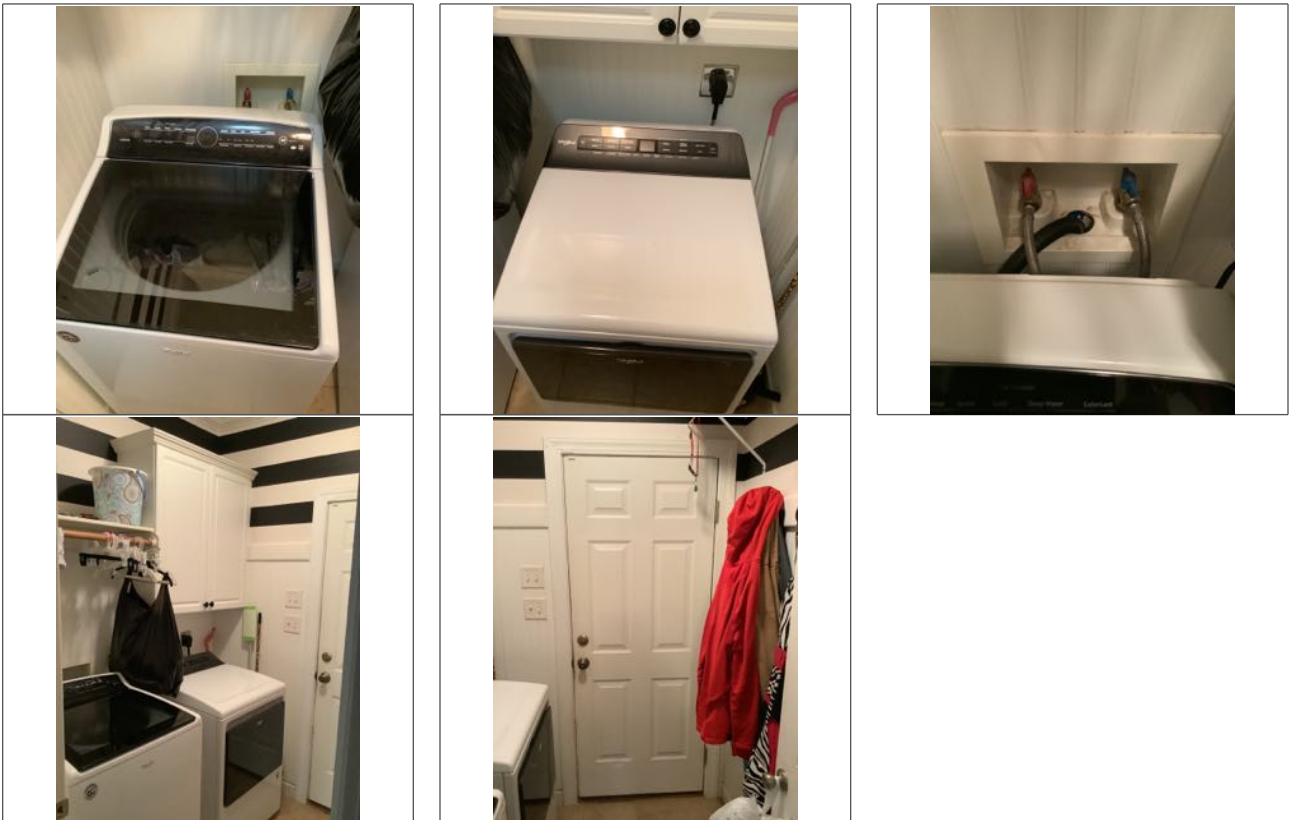
**Comments:** 1. The inside of the the ductwork for the dryer exhaust was only inspected from the ductwork openings on the interior and exterior of the home, if the openings were accessible. Dryer ductwork must be maintained/cleaned at least once a year. It is impossible to determine if the entire ductwork is free of lint buildup during a limited visual inspection. According to the standards of practice, washers and dryers are not considered built in appliances and are not ran during a home inspection. The client should have a skilled professional clean the ductwork routinely, and may wish to have it cleaned now, or consult with the current owner to determine when the ductwork was last cleaned.

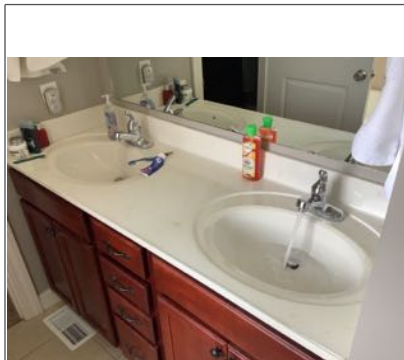
**Comments:** **Further Evaluation Item: 1. The drainage in the sink is slow/marginal in the bathroom.** The sink is not draining properly. If a clog cannot be removed from the drain, recommend a qualified plumber evaluate and make repair.

Right sink drains slow

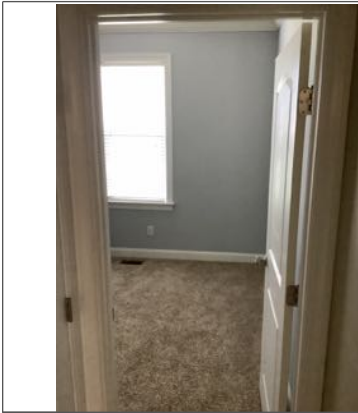
**Comments:** Smoke detector within this room is not operational. Did not test property. recommended replacement immediately.

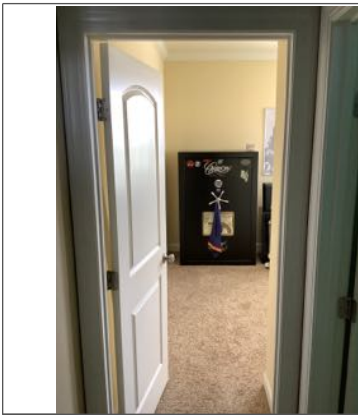
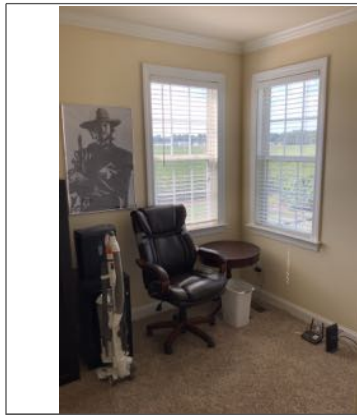
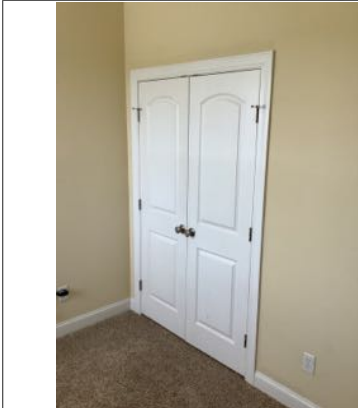
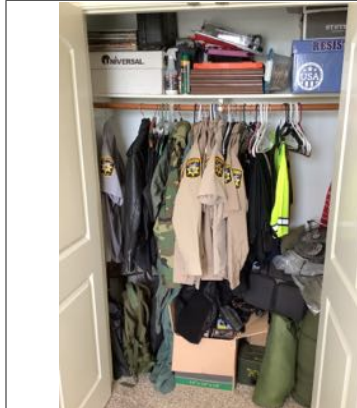
**Comments:** 1. There is an object stuck in the slot of an outlet in the room. The outlet cannot be used and this could become a shock hazard. Recommend a skilled professional/qualified electrician remove the object.

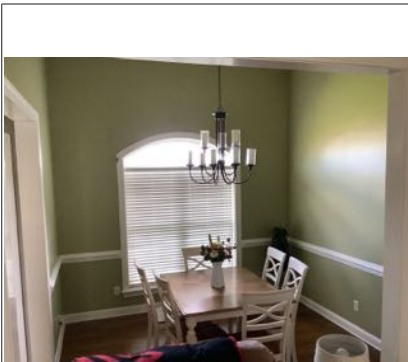
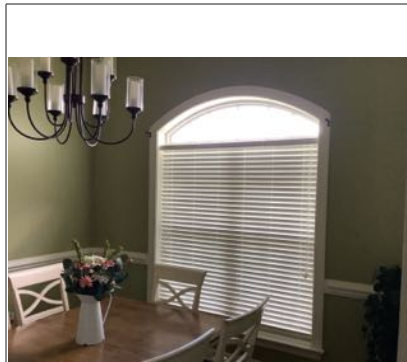
**Comments:** 1. There is an area of what appears to have been staining that was painted over on the ceiling in the room. This area was tested with a surface moisture meter and the meter indicated low levels of moisture in some spots at the time of inspection. In some cases moisture meters can give false readings when they come in contact; or within close proximity to metal. It is difficult to determine if this is an active leak. The client may wish to have a more invasive inspection in this area by a skilled professional. At a minimum recommend monitoring and if further deterioration, staining or cracking occur recommend a skilled professional/qualified contractor evaluate the condition.

Dormer window located within attic. There is evidence of past water intrusion around this windows and staining on the attic floor. Further evidence of water intrusion is located in the dining room ceiling. These spots were tested using a moisture meter and showed no moisture differential between stain and surrounding areas.

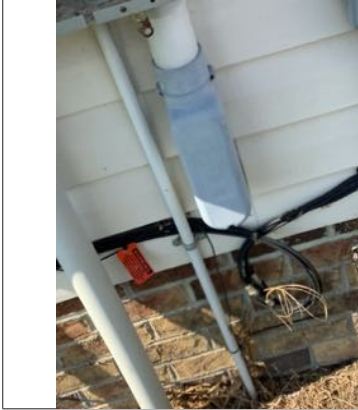
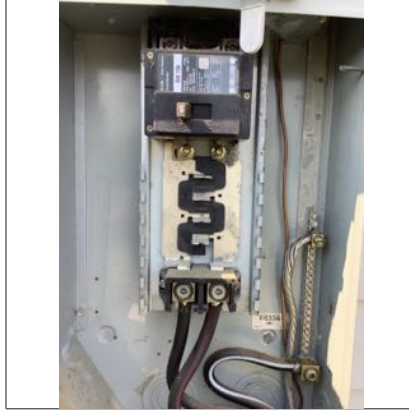
Condition  Satisfactory

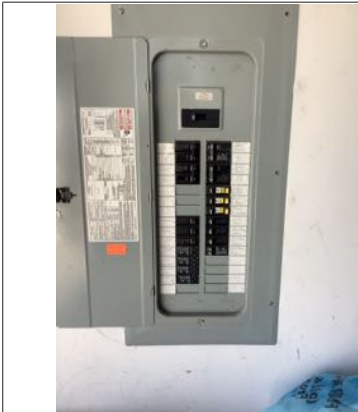
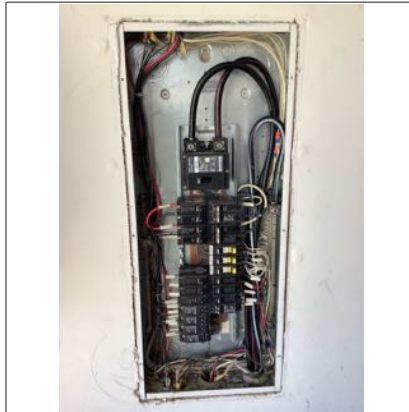
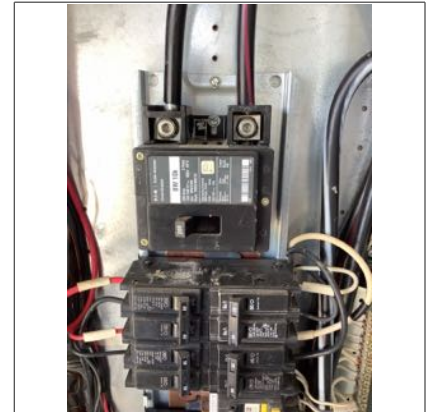
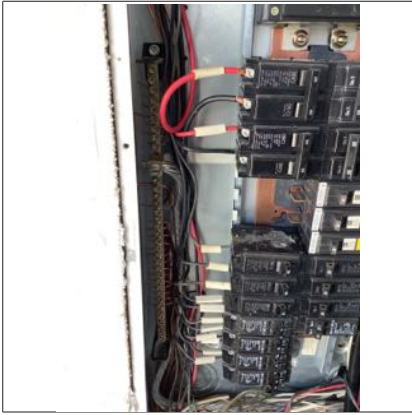
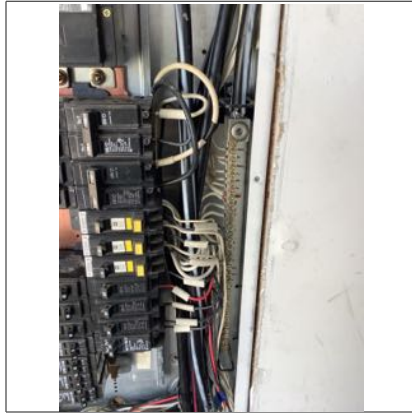
Gen. Cond.  Satisfactory

Branch cond.  Satisfactory
